# Reliance Home Inspection

## Inspection Report Summary

**Address: 123 Dream Home Lane**

**Date: 6/25/05**

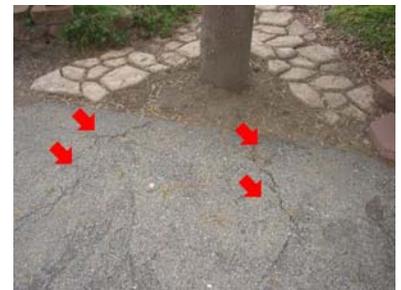
**CONDITION:** General condition appears serviceable with the exception of the following item(s) listed below. Cracks were noted. We recommend sealing these cracks to prevent erosion. A tree at the edge of the driveway appears to have caused damage to the driveway. The damage may continue unless the tree is removed. We recommend consulting with a licensed arborist.

**REMARKS** Various tripping hazards noted around the outside of the home = use caution and repairs recommended.

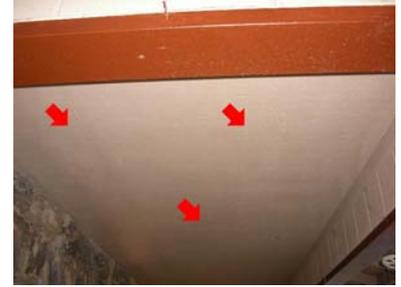
General condition appears serviceable with the exception of the following item(s) listed below. The front porch overhang is a soffit type construction without ventilation = installation of ventilation is recommended.

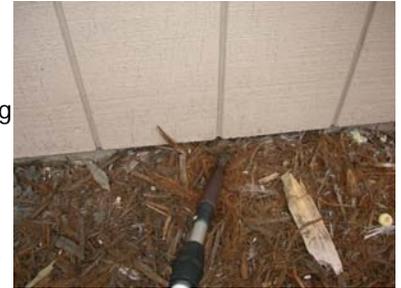
Appear serviceable. The recommended clearance for siding is 6" above soil and 2" above hardscape such as concrete. Trees and or bushes are planted close to the home. The home may be subject to damage from falling debris. This may also be a fire hazard. We recommend trimming bushes and trees away from the home for safety enhancement. Gaps noted in the siding at corner(s) needing sealing to help prevent moisture intrusion = seal with caulking and or trim stock. Lower grade in few areas. Unable to view under the alcove on the left side of the home due to height restrictions.

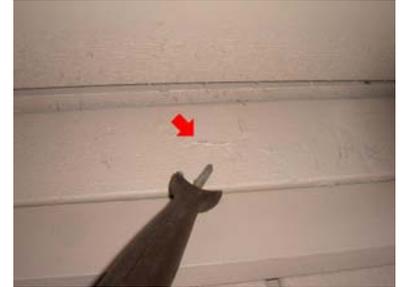
General condition appears serviceable with the exception of the following item(s) listed below. Damage or deterioration was noted to the paint or finish in a few areas. We recommend painting.

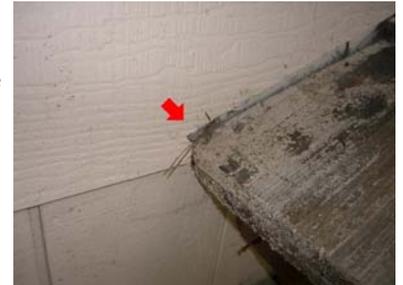
Metal. The general condition appears serviceable with the exception of the following item(s) listed below. Exposed nails were noted on some of the flashings. We recommend sealing the top of the nails with mastic. A proper kickout flashing at the roof to wall connection is not visible. This can lead to water intrusion. We recommend having kick out flashings installed.

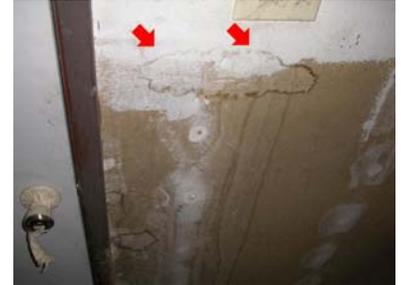
Appears serviceable. Walls of the garage were not fully visible due to stored items. Moisture stains were noted on the wall(s) of the garage.

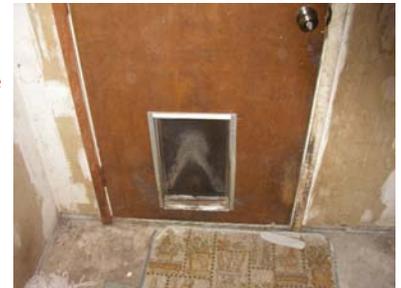
Appears serviceable and is a solid core or metal type door. Self closer is functioning properly. **Pet door penetrates through the door. This compromises the fire rating of the door. This is a safety hazard.** Correction is recommended.

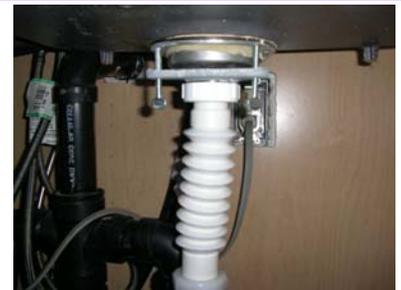
The general condition appears serviceable with the exception of the following item(s) listed below. An improper flex type drain line was noted. This type of fitting is not approved by the UPC. Debris can get caught in the ribs of this type of drain line. We recommend installing an a UPC approved drain line.

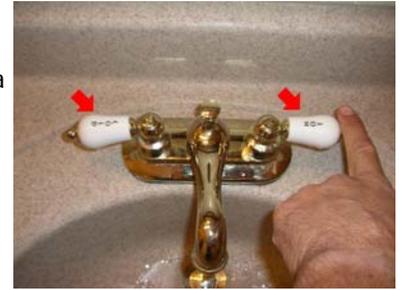
Hot and cold were reversed at the sink faucet. This is a potential safety hazard. Correction is recommended. Even though the valves are labeled as such this is still a safety hazard and correction is recommended.

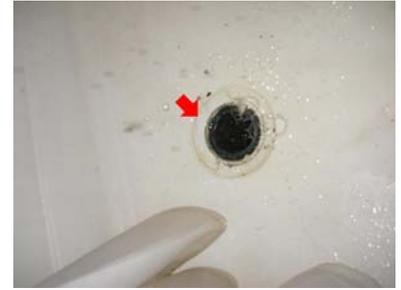
The drain cover/screen is missing in the shower, there is a possibility of moisture entering around this area = We recommend further evaluation and repairs by a licensed plumbing contractor.

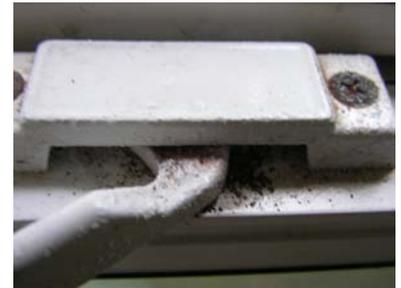
The locks were missing or did not function properly at the following window(s): Middle bedroom and master bathroom locks inoperable = repairs needed. Corrosion noted on the window locks in the bedroom alcove.

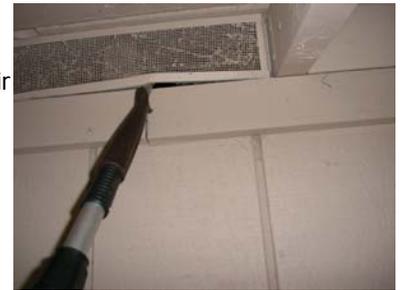
The general condition appears serviceable with the exception of the following item(s) listed below. Screen(s) noted to be bent creating an opening = repair to help prevent pest entry.

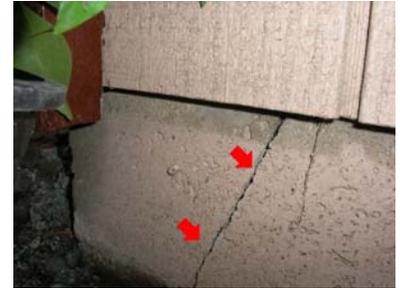
Cracks noted = monitor for and changes in size or differential.

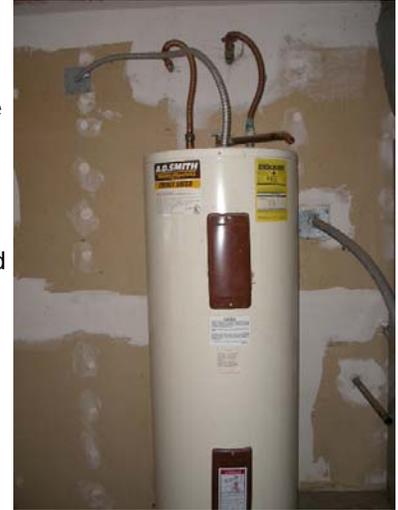
**No straps installed. This is a safety hazard.** We recommend a metal strap wrapped completely around and fastened to the studs on either side at the top 1/3 and bottom 1/3 of the unit. If the unit is away from the wall, a block for behind the unit is also recommended so that the unit does not move. We recommend installing blocking behind the unit to keep it from moving backward during an earthquake. We recommend further evaluation and repairs by a licensed plumber. Concrete protection bollard(s) should be installed in front of the water heater to protect the unit from physical damage from vehicle(s). Electrical cover missing at the top of the unit = replace.

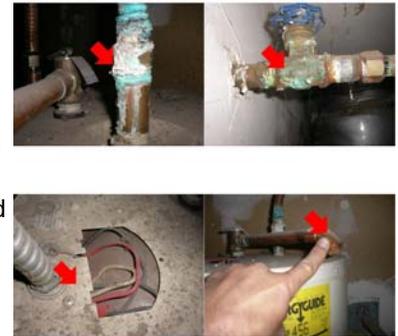
**The pressure relief valve drain line was missing or ended prematurely. This is a safety hazard, correction is needed.** We recommend correction by a licensed plumbing contractor. Corrosion was noted on supply valve(s) above the water heater. This may be an indication that the valve(s) have leaked in the past. We recommend attention, repair or monitoring. We recommend further evaluation and repairs by a licensed plumber.

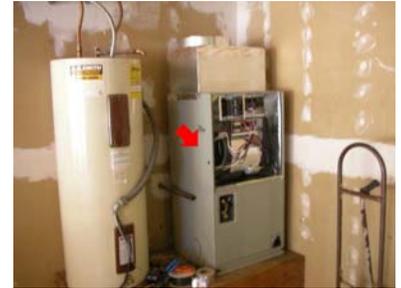
**SYSTEM TYPE:** Forced air furnace. A new electric furnace was being installed in the garage during the inspection.

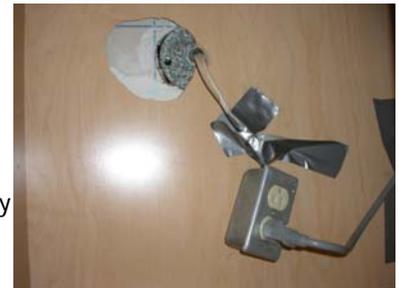
A representative number was tested and the outlets generally appeared serviceable. A loose outlet was noted in the left rear bedroom. Correction is recommended. Open ground left front and rear bedroom. Outlet dangling in the cabinet above the microwave = repair needed. Outlet located underneath the main electrical panel, the cover does Not fit properly the interior of the box is exposed = repair needed.

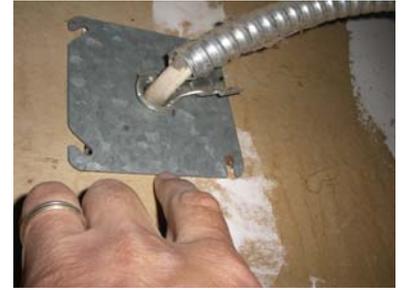
**GARAGE WIRING NOTES:** Clamp missing from the armored cable for the water heater connection = repair needed.

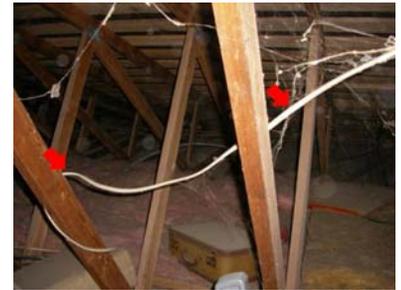
**WIRING NOTES:** Conductor(s) noted in various area(s) that should be reinstalled properly = safety hazard.
