Reliance Home Inspection

Inspection Report Summary

Address: 456 Santa Cruz Dr.

Date: 06/17/2005

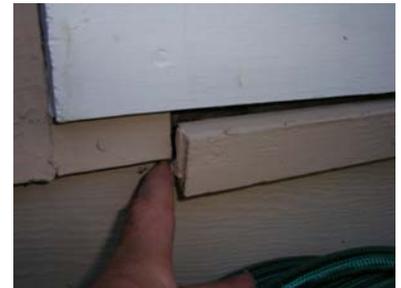
WINDOW, DOOR & WALL TRIM CONDITION:

General condition appears serviceable with the exception of the following item(s) listed below. No flashings were visible above the window and door trim. This is typical on older homes. They rely on caulking to prevent intrusion. We recommend monitoring the caulking at the trim to wall connection and re-caulking when necessary. Loose trim was noted at the front of the home. We recommend repair. We recommend repair.

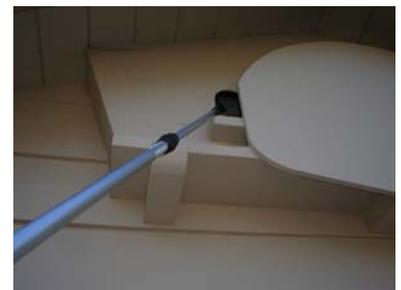
EAVE CONDITION:

The eaves, soffits & trim generally appear serviceable. The decorative area above the garage should be screened off to prevent birds from nesting.

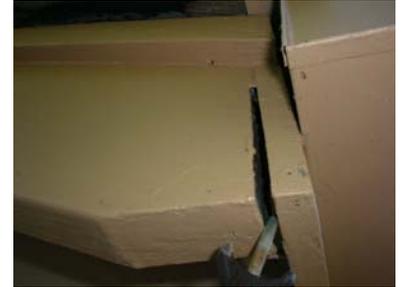
FACIA CONDITION:

General condition appears serviceable with the exception of the following item(s) listed below. Fascia noted to be separating from the eave(s) in a few areas = repairs needed.

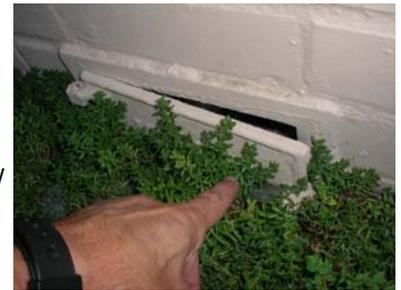
A spark screen was installed Unable to open ash door due to grade = lower grade. Due to the limited view we recommend further evaluation by a Qualified Licensed Chimney sweep and possible a level 2 inspection before the unit is used and before the close of escrow on the home. Unable to determine if chimney crown is cracked or not due to recent painting.

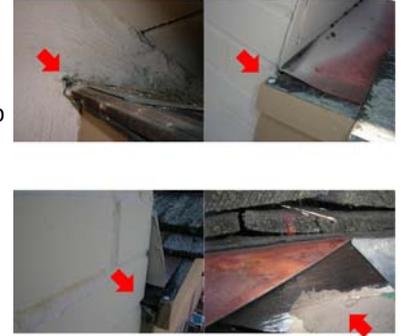
Metal. The general condition appears serviceable with the exception of the following item(s) listed below. Chimney, eave, transition flashing(s) inadequate exposed area(s) for possible moisture intrusion = repairs needed. A proper kickout flashing at the roof to wall connection is not visible. This can lead to water intrusion. We recommend having kick out flashings installed.

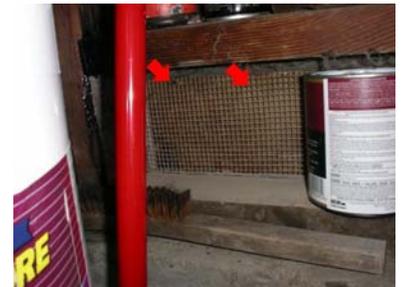
The general condition appears serviceable with the exception of the following item(s) listed below. The vent(s) in the garage were covered. We recommend removal of the cover to allow for proper ventilation of the garage. Unable to evaluate due to storage of personal items.

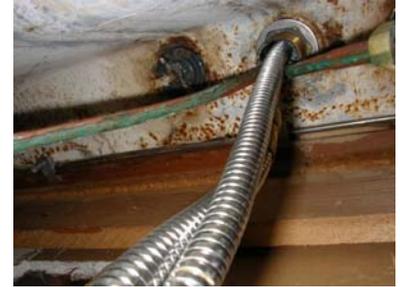
Faucet is serviceable. The general condition appears serviceable with the exception of the following item(s) listed below. Corrosion noted on the pipes below the sink. Typical marring noted from usage. Caulking recommended for the sink to counter connection.

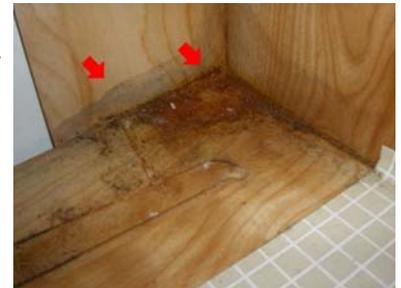
Moisture stains were noted below the kitchen sink. We recommend monitoring in the future. Storage of items. Hole(s) noted in wall under sink area = recommend sealing to keep out vermin.

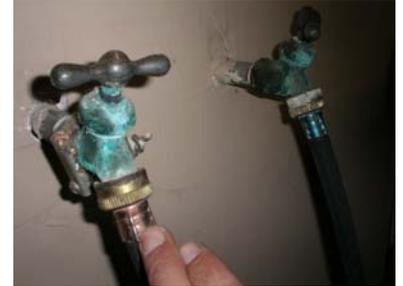
PLUMBING: Corrosion is noted on the laundry valves. We recommend monitoring.

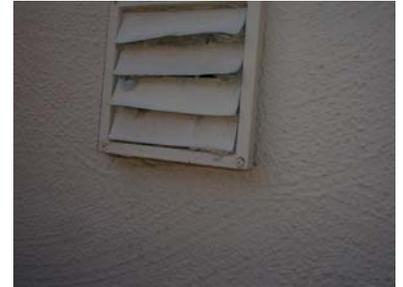
VENTING: Dryer venting is provided. The general condition appears serviceable with the exception of the following item(s) listed below. The ducting louver stays open = repair/replace. There is a second exhaust duct termination on the left side of the home that is open to vermin entry = repair.

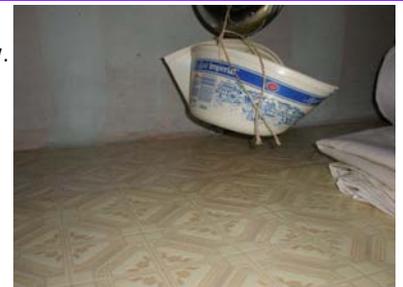
CONDITION OF SINK: Caulking is recommended for the sink to counter connection. The drain stopper did not operate properly. We recommend repair. Corrosion noted on the supply plumbing below the sink. There is a plastic margarine bowl tied up under the sink drain = repairs needed.

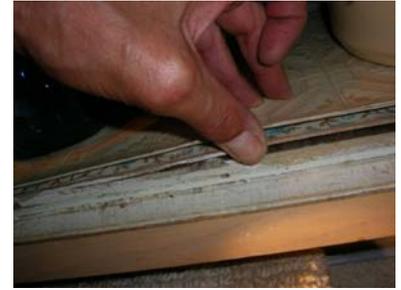
CABINET- MIRROR- DRAWER CONDITION:

Damage was noted to the cabinet below the sink.

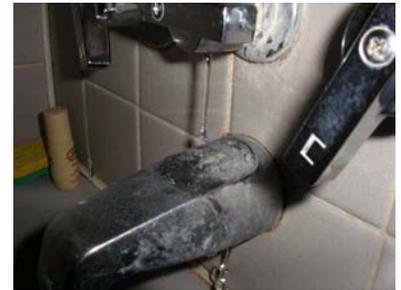
TUB/SHOWER PLUMBING FIXTURES:

Corrosion noted on the plumbing fixture(s) and the fixture(s) leak = repairs needed.

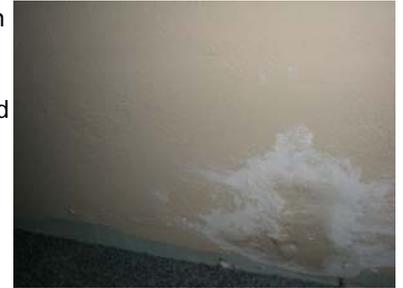
INTERIOR WALLS:

MATERIAL & CONDITION: Drywall. The general condition appears serviceable with the exception of the following item(s) listed below. Damage was noted to the wall in the living room. We recommend repair. Peeling wallpaper in the hallway and master bathroom noted.

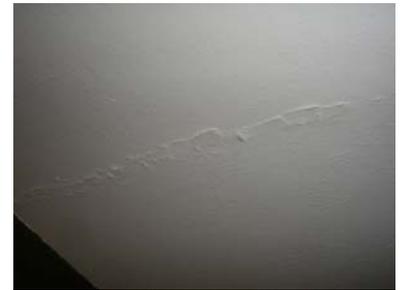
CEILINGS:

TYPE & CONDITION: Seams visible right front bdrm and Family room. General condition appears serviceable.

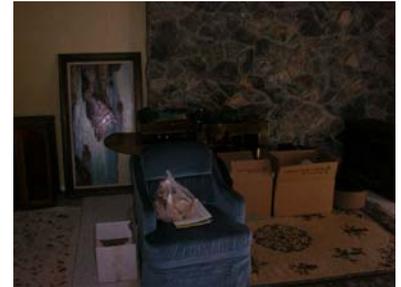
LOCATION: Family room.

CONDITION: Unable to evaluate to due storage of items and furniture = inspector not allowed to move such items. We recommend cleaning and inspection by a qualified fireplace contractor before use due to inability to view fire box and limited view caused by chimney cap and screen above.

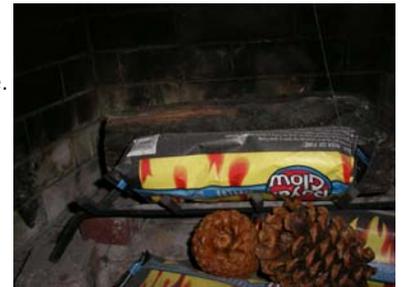
CONDITION: Damper is operational. Cracked/Loose/Damaged Fire Brick. Items evaluation. We recommend cleaning and inspection by a qualified fireplace contractor before use. Limited view due items in fireplace.

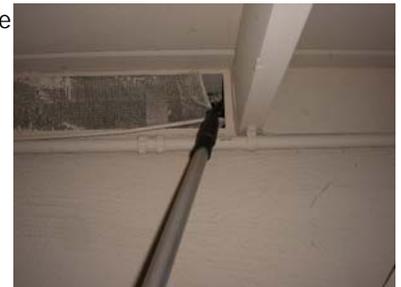
VENTILATION:

There appears to be minimal ventilation in the attic. The installation of additional vents is recommended. The screen for the gable end ventilation is deteriorated and screen(s) damaged = repair/replacement to help keep vermin out.

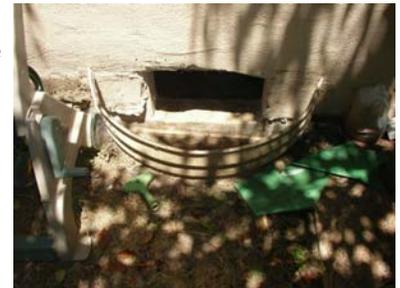
Crawl space is fully accessible. The door to the crawlspace was located on the exterior right side of the home. Deterioration was noted to the crawlspace door. We recommend repair.

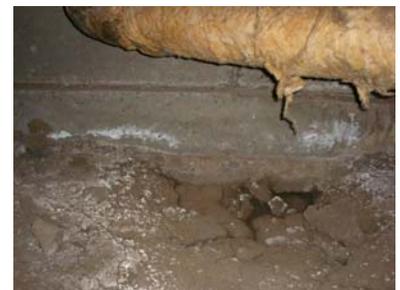
CRAWL SPACE CONDITION:

Appears serviceable. The floor of the crawlspace was dry at the time of our inspection. The floor of the crawlspace was dry at the time of our inspection. The general condition appears serviceable with the exception of the following item(s) listed below. Efflorescence and some erosion noted on the foundation at the right front area of the home; this is most likely being caused by the planter at the front of the home = recommend moisture barrier between the foundation and the planter.. This is a white substance which forms on some foundations but causes no damage. Some piers and posts are out of plumb. Moisture noted on the outside wall(s), most likely from the high grade level = lower grade and monitor.

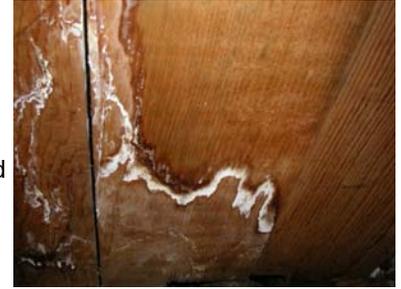
Moisture stains and or corrosion noted to the plumbing were noted in the sub-floor below the hallway bathroom, master bath and laundry drain areas. Wood which is exposed to water will typically attract pests or rot. Correction of the moisture cause is needed. We recommend further evaluation and repairs by a licensed contractor.

SUB-FLOOR CONDITION: Moisture stains and or corrosion noted to the plumbing were noted in the sub-floor below the hallway bathroom, master bath and laundry drain areas. Wood which is exposed to water will typically attract pests or rot. Correction of the moisture cause is needed. We recommend further evaluation and repairs by a licensed contractor.

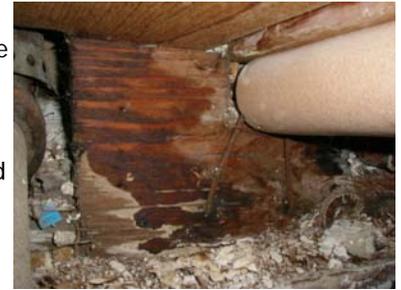
FLOOR JOISTS CONDITION:

The general condition appears serviceable with the exception of the following item(s) listed below. Moisture stain(s) noted to the rim joist which is the outer most floor joist these areas appear to be affected by the waste plumbing like the laundry drain etc. We recommend further evaluation and repairs by a licensed contractor.

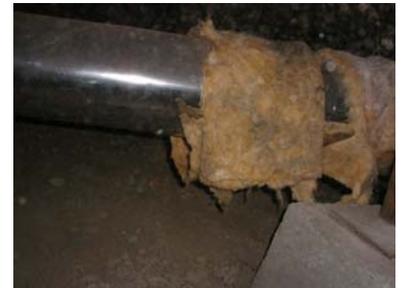
OTHER OBSERVATIONS: Insulation hanging off of the HVAC ducting = repair/replace.

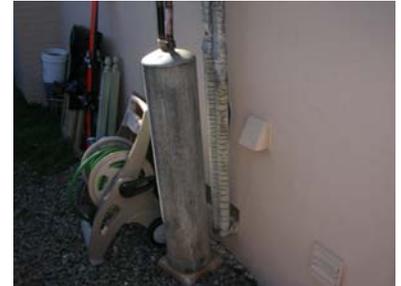
WATER PRESSURE:

55PSI. This is within the normal range of between 40 and 80 PSI. Client mentioned water flow Not to their liking, there is a Culligan tank in the left side yard they might be restricting some of the flow to the home, this tank is not secured = safety hazard. The Culligan tank is beyond the scope of this inspection.

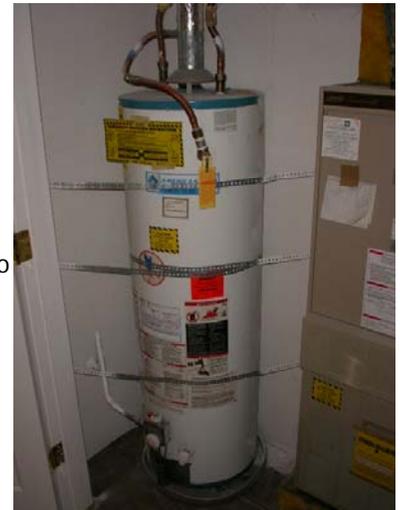
Interior closet. Current safety standards prohibit the installation of gas burning appliances in interior closets. We recommend having the closet further evaluated for the sufficient seal at the bottom of the closet doors to prevent combustion gases from entering the home and for sufficient combustion air for the appliances within this area including the furnace. The other option would be to relocate all gas appliances to a safer location. There is a vent in the ceiling, but it appeared to be blocked.

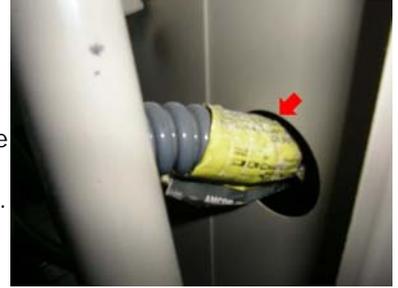
The general condition appears serviceable with the exception of the following item(s) listed below. The unit did not appear to have been cleaned or serviced recently. We recommend cleaning and servicing by a licensed heating contractor. The furnace was very close to the walls of the closet or compartment. It may not meet the manufacturers minimum installation set backs. We recommend reviewing the manufacturers installation instructions to determine if the unit has the proper setbacks. The gas flex line is routed through the housing, this is a safety item and should be corrected to a solid pipe. In the case of seismic activity the flex line can rupture. This is an older furnace and does Not have a safety cut-off switch for the removal of the housing panels = installation recommended and caution needed when opening to change the filter or for any other reason make sure furnace is turned OFF.

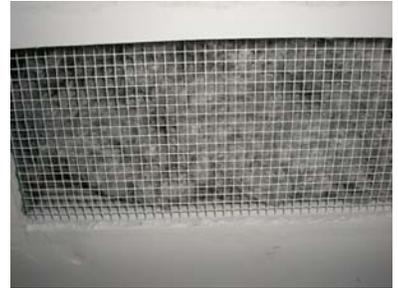
COMBUSTION AIR:

Appears to be blocked. Further evaluation needed.

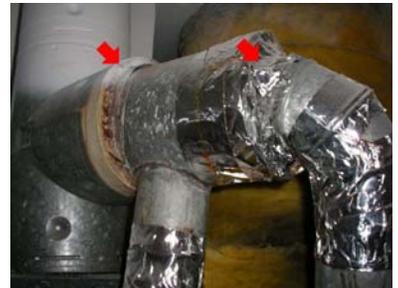
VENTING:

Asbestos like wrap was noted on seam(s) of the vent pipe. This is a potential health hazard. We recommend testing of the wrap to determine if it contains asbestos. If the wrap does contain asbestos, we recommend removal by an abatement contractor. Not sealed properly.

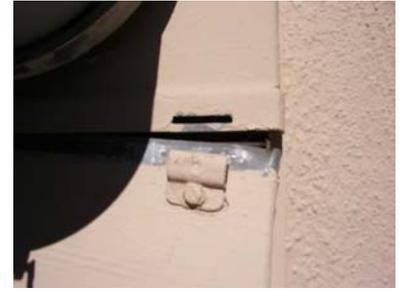
The general condition appears serviceable with the exception of the following item(s) listed below. Cover loose repair. The ground was noted to be connected only to the water supply plumbing, this is no longer accepted as a stand alone ground = installation of a proper ground system such as an approved rod is recommended by a Qualified Licensed Electrical Contractor.

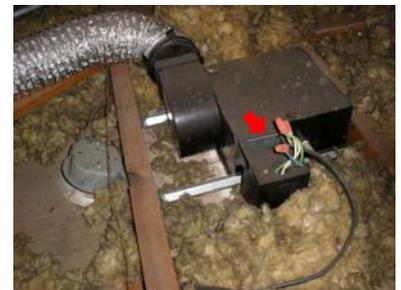
EXPOSED SPLICES:

Exposed splice(s) were noted in the attic. Current standards call for all splices to be made inside a closed junction box. This is a safety hazard. We recommend the installation of junction boxes for these splices.

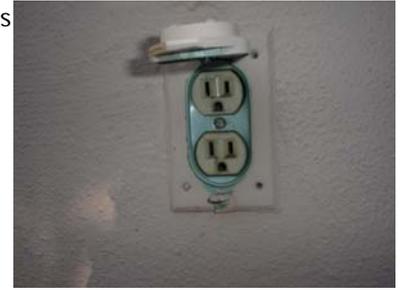
A representative sampling of switches, outlets and lights were tested. As a whole they appeared to be in serviceable condition. There are no GFCI outlets installed at the exterior. This is a safety hazard. This type of outlet has a circuit breaker which will shut off the flow of electricity in the event of a ground fault. This means they shut off if you get shocked. Although GFCI outlets may not have been a requirement when this house was built, we recommend upgrading for safety enhancement. A spotlight located at the front of the home is disconnected.

A representative sampling of switches, outlets and lights were tested. As a whole they appeared to be in serviceable condition. **There are no GFCI outlets installed at the exterior. This is a safety hazard.** This type of outlet has a circuit breaker which will shut off the flow of electricity in the event of a ground fault. This means they shut off if you get shocked. Although GFCI outlets may not have been a requirement when this house was built, we recommend upgrading for safety enhancement. A spotlight located at the front of the home is disconnected .
