# Reliance Home Inspection

## Inspection Report Summary

**Address: 123 Dream Home Lane**

**Date: 6/25/05**

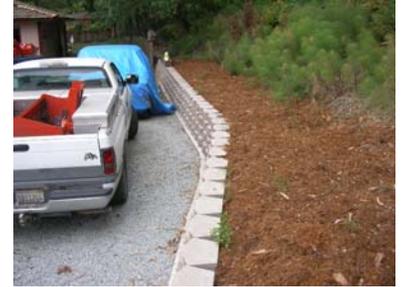
## RETAINING WALLS:

**TYPE:** Masonry block.

**CONDITION:** The general condition appears serviceable.

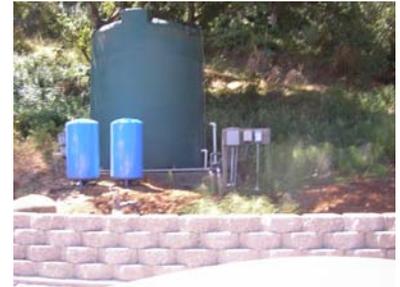
At water tank and at the right side of the home.

Appears serviceable. Valve not tested.

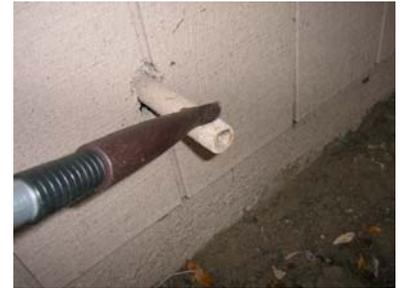
The home operates on all electrical appliances. The current owner explained to the inspector that there is plumbing in place to install propane to the garage.

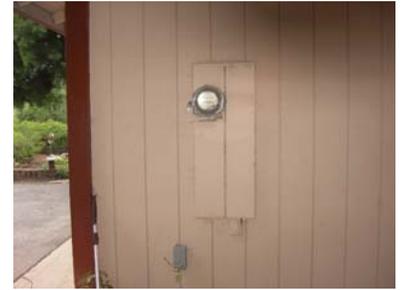
Located at the exterior right of the home.

Breakers are without the benefit of proper labeling. The grounding electrode was not visible at the time of our inspection. Corrosion is noted within the electrical panel. No lock was installed on the panel cover. This is a safety hazard for children who might mistakenly touch the internal components of the panel and receive a shock. We recommend the installation of a lock for safety enhancement. The dead front cover is a type which does not have screws to keep the dead front cover in place. This can be a safety hazard for children who could open the panel. We recommend the installation of a lock or screws which will make the removal of the dead front cover difficult for children.
